LA-UR-17-31263

Title: Surveillance Report on SAVY-4000 and Hagan Nuclear Material Storage Containers for FY 2017

Issued: 2017-12-22 (rev.1)

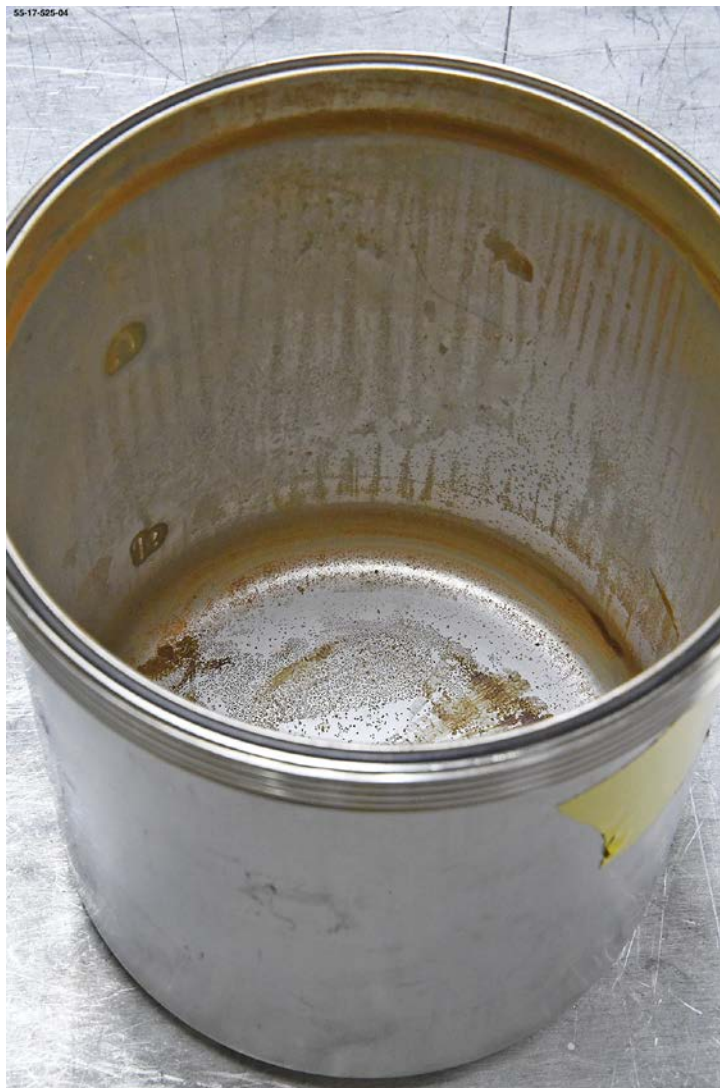
Corrosion was found in this container. There were no visible signs that the exterior of the container was corroded. The container walls show more general corrosion than the lid with heavier general corrosion in the weld regions seen in Figure 4-1. There are markings that are likely where the bag out bag was touching the container especially on the bottom of the container seen in Figure 4-2. Upon opening, the container there was a smell of chlorine. The bag out bag was reported as being good but gooey/sticky. Photographs of the bag out bag show it as being darkened as well in Figure 4-3. Until the item was introduced, a good look at the inner container was not clearly visible. The outside of the inner container was corroded (Figure 4-4.) The inside of the inner container was also corroded (Figure 4-5,) though not as heavily as the outside.

Figure 4-1. Sample #17H1 container showing corrosion on the inside of the container. Heavier deposits in weld regions and along bottom radius.

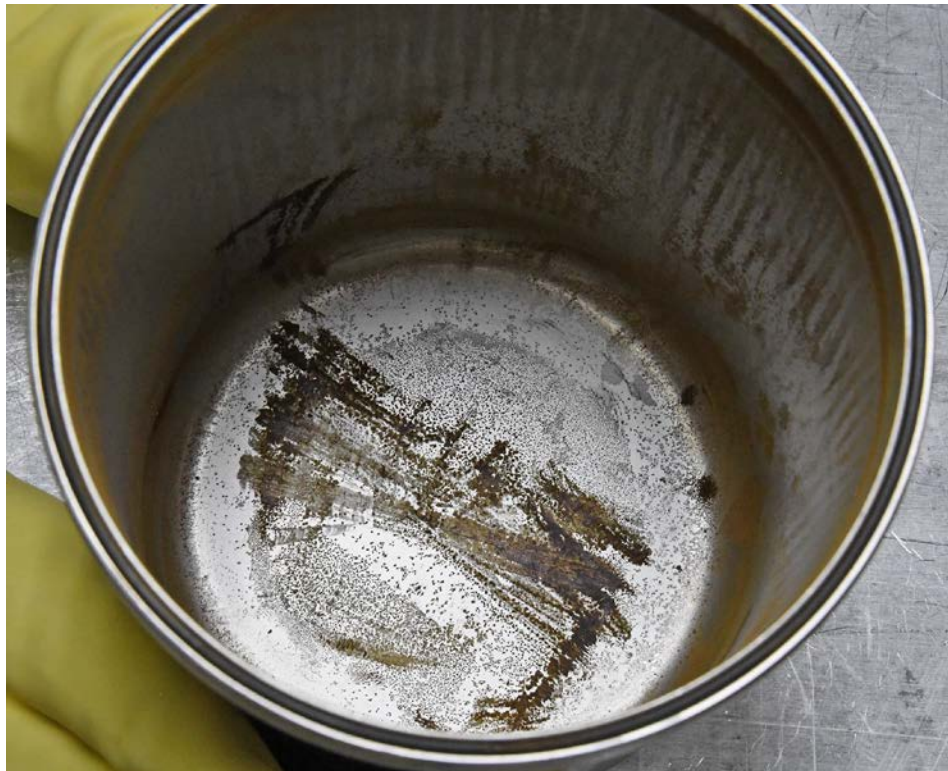
Figure 4-2. Bottom of the sample 17H1 with markings where the bag out bag was in contact.

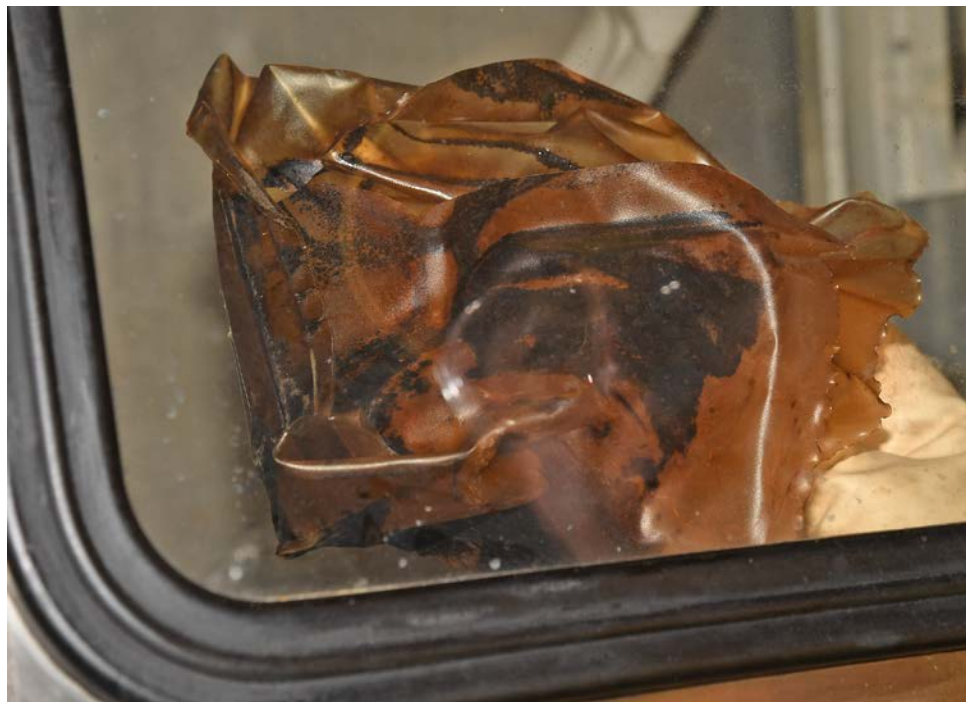
Figure 4-3. Bag out bag inside the glovebox after being removed from the container 17H1.

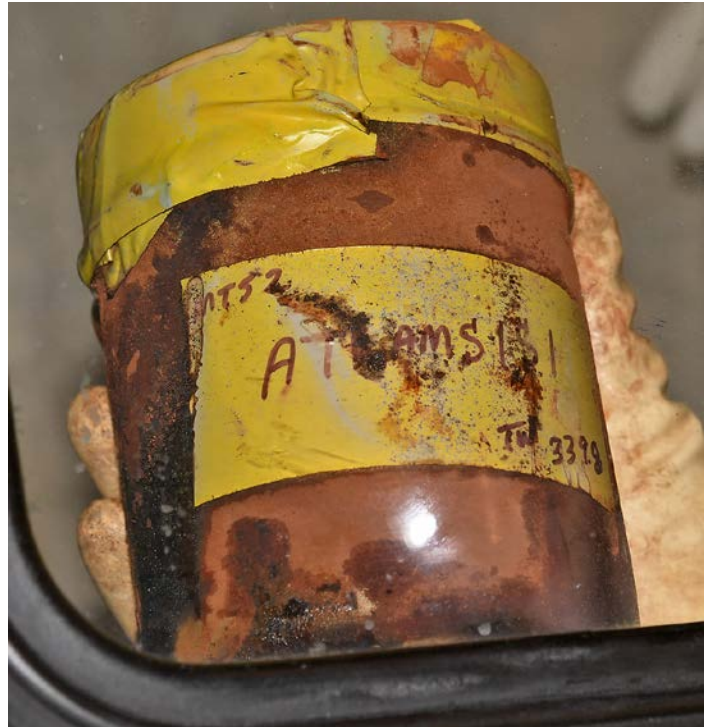
Figure 4-4. Inner container of container 17H1 with corrosion evident on the outside of the container.

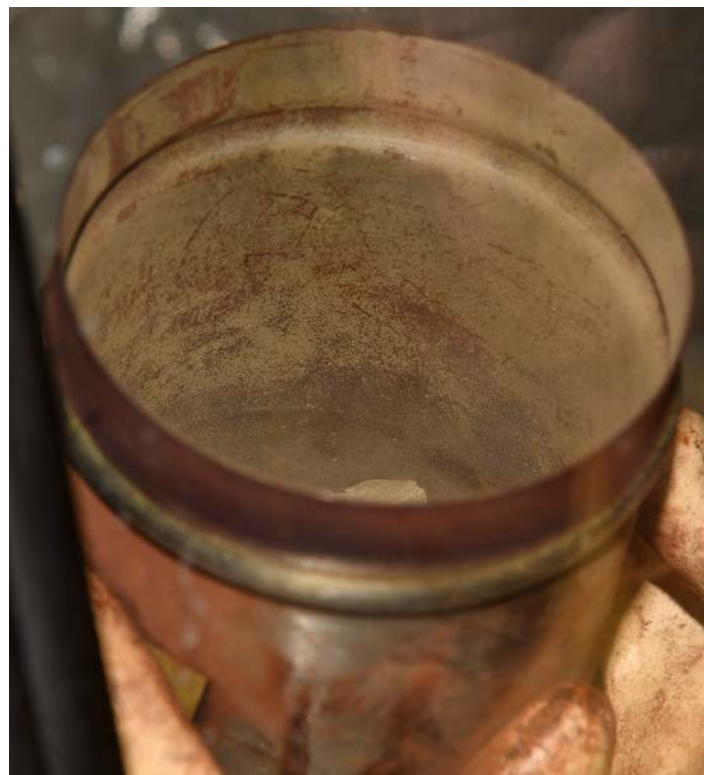
Figure 4-5. Inside of the inner container of container 17H1 which had some corrosion but was not as severe as the outside of the inner.

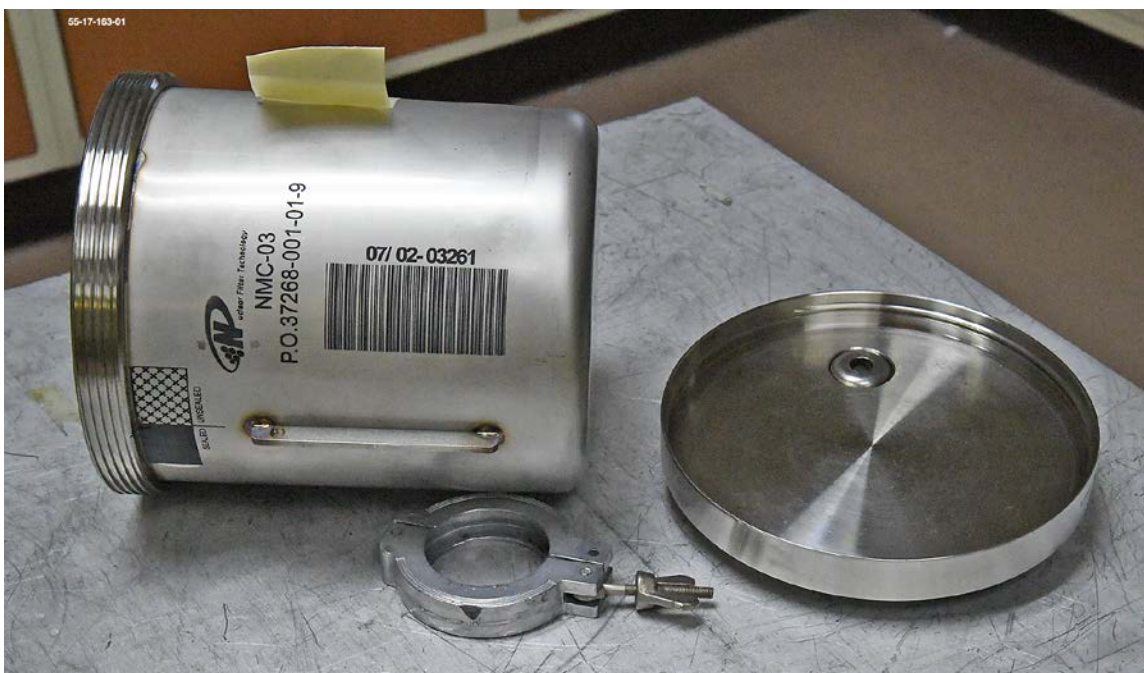
Corrosion was found on the interior surfaces of both the lid and body of the container. The exterior of the container did not show any corrosion signs (Figure 4-6). There is a speckle pattern found on the inside of the container and lid (Figure 4-7, Figure 4-8) where it appears corrosion is forming. A heavier deposit of corrosion products can be found in the heat affected zone around the welds on the container (Figure 4-8). This Hagan container is also a 2-thread lid type. Corrosion was also reported on the inner container at the time of unpacking. The bag-out bag was reported as being discolored but pliable. This

Figure 4-6. Exterior of container 17H2 showing no corrosion

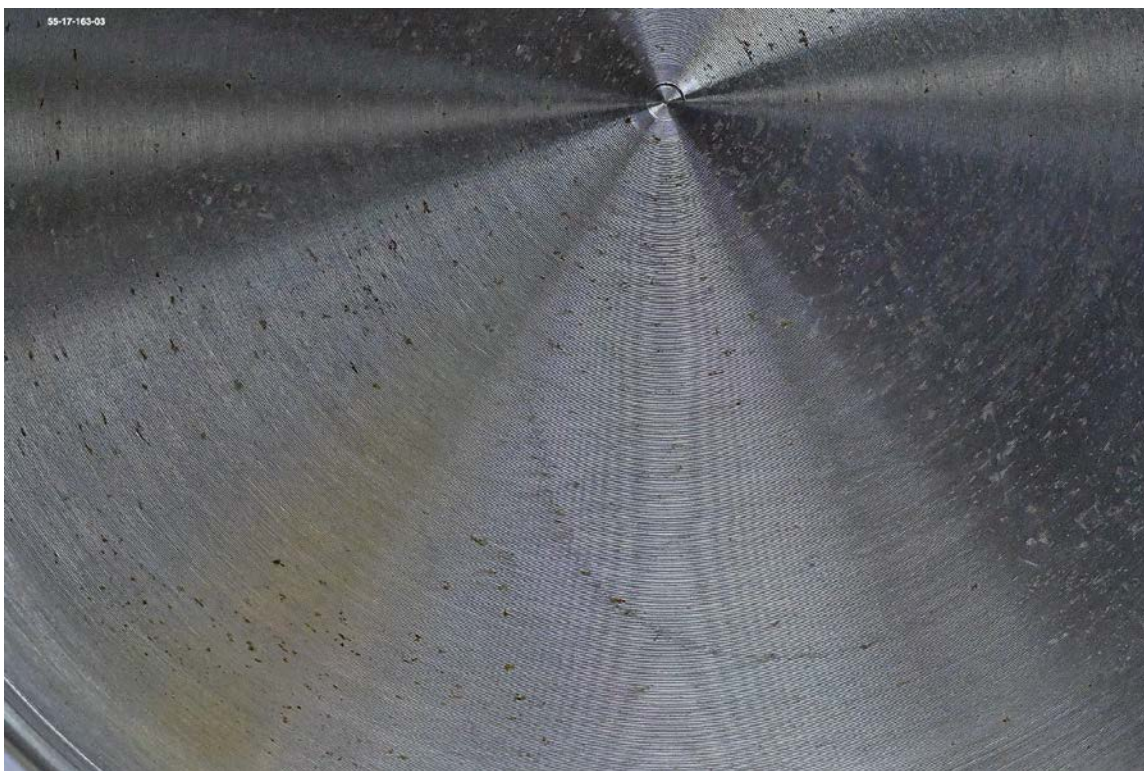
Figure 4-7. Underside of lid of 17H2 with spots of corrosion

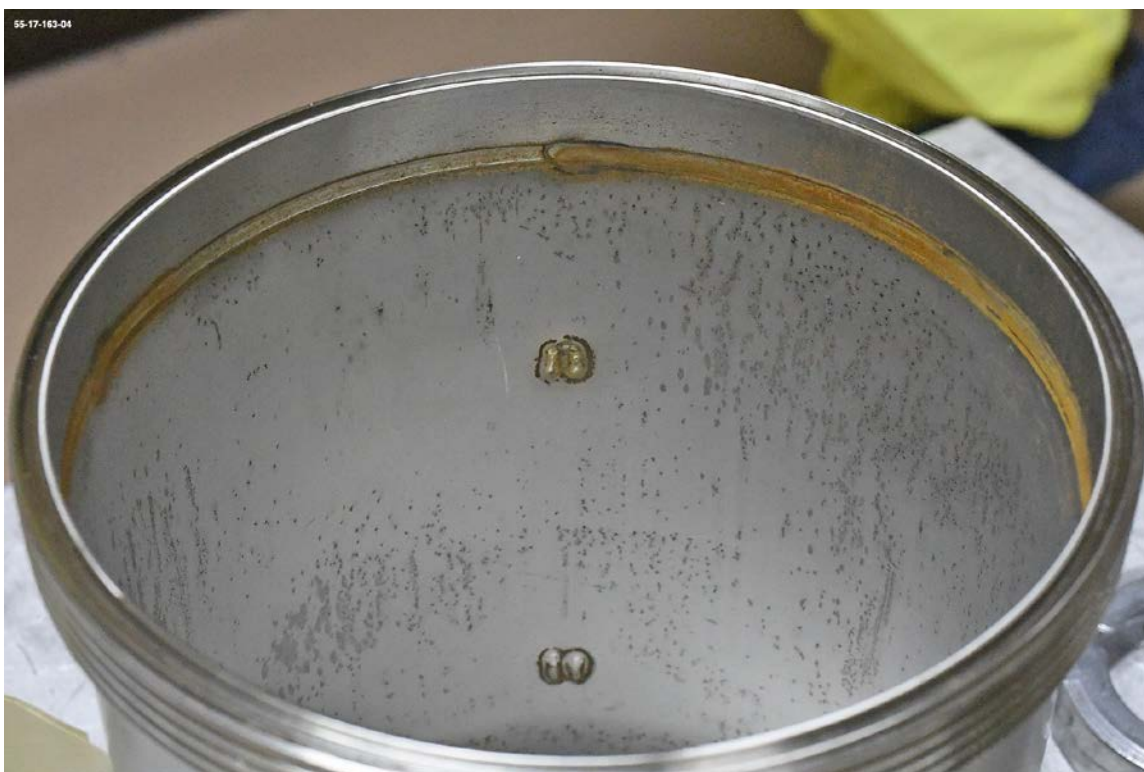
Figure 4-8. Corrosion on interior of 17H2 with heavier deposits in the weld region

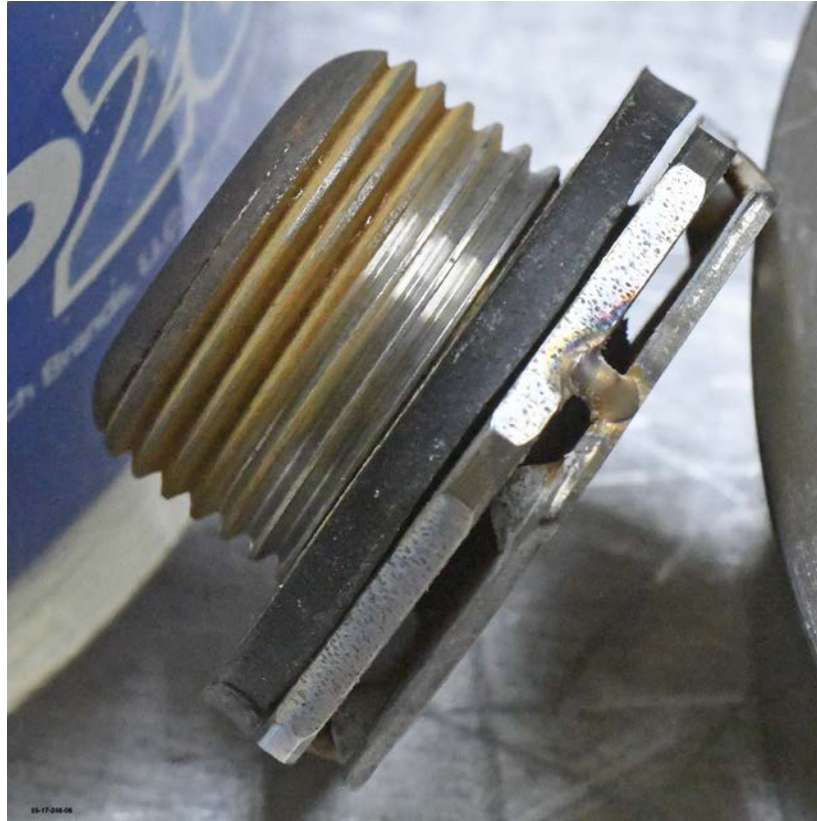
Corrosion was found on the interior surfaces of both the lid and body of the container. Corrosion was also found on the threads of the filter holder (Figure 4-9). The exterior of the container did not show any corrosion signs. There is a speckle pattern found on the inside of the container and lid (Figure 4-10). There are heavier concentrations of corrosion products in the weld regions of the collar weld, Figure 4-10, and the welds, which hold the TID bar on the container, Figure 4-11. A heavier deposit of corrosion products can be found in the heat affected zone around the welds on the container. This Hagan container is also a 2-thread lid type. Corrosion was also reported on the inner container at the time of unpacking. The bag-out bag was reported as being discolored but pliable.

Figure 4-9. Corrosion on threads of the filter housing of container 17H7.

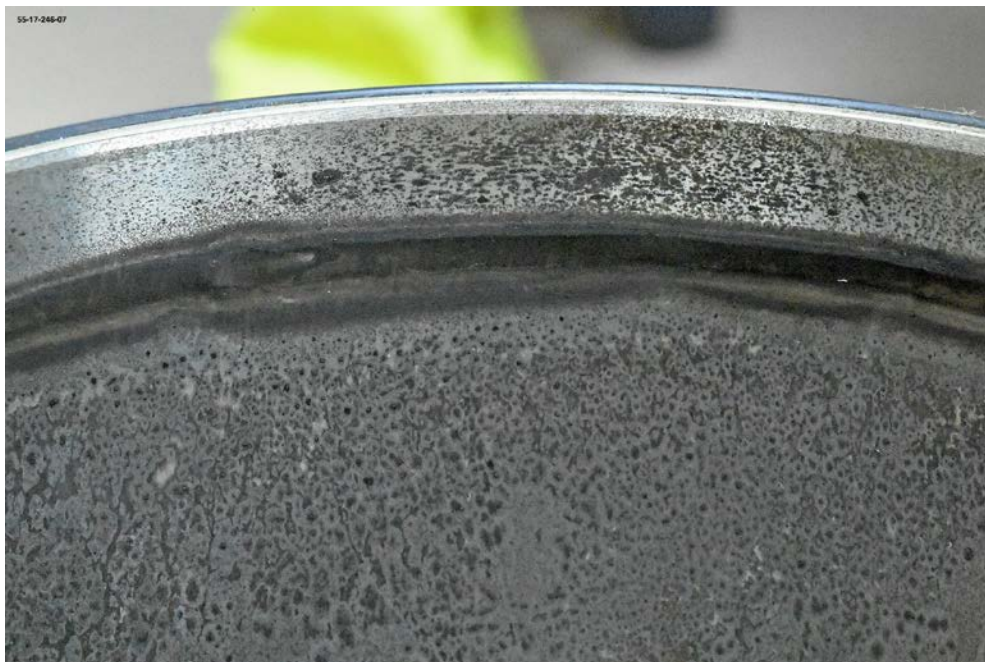
Figure 4-10. Deposits on the inner wall of the container 17H7

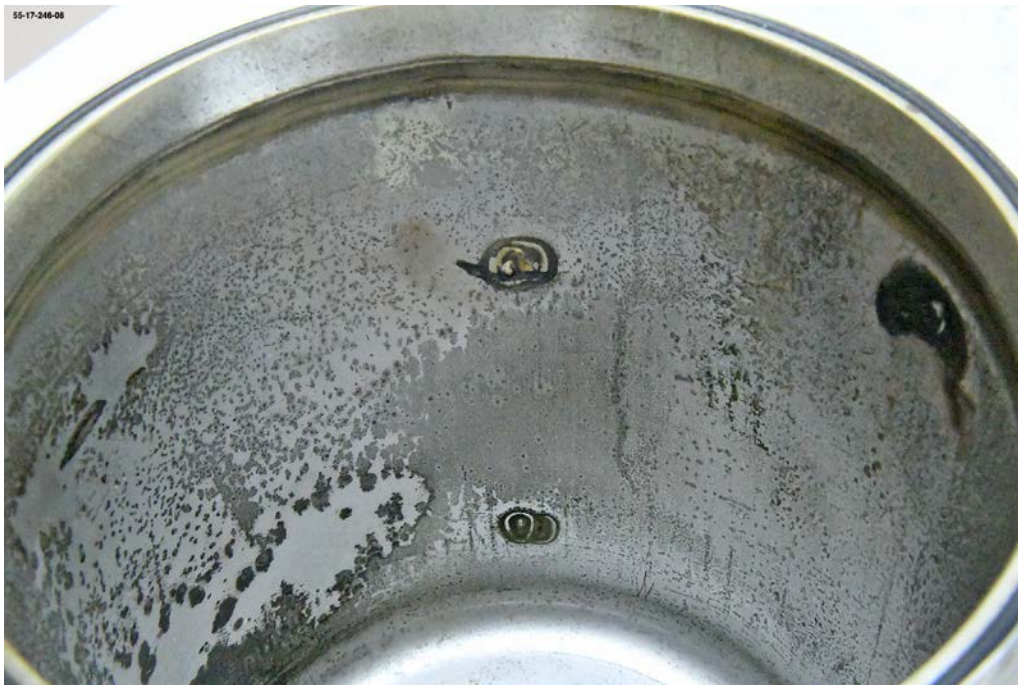
Figure 4-11. The corrosion deposits found on the heat affected zone of the welds holding the TID bar of container 17H7.

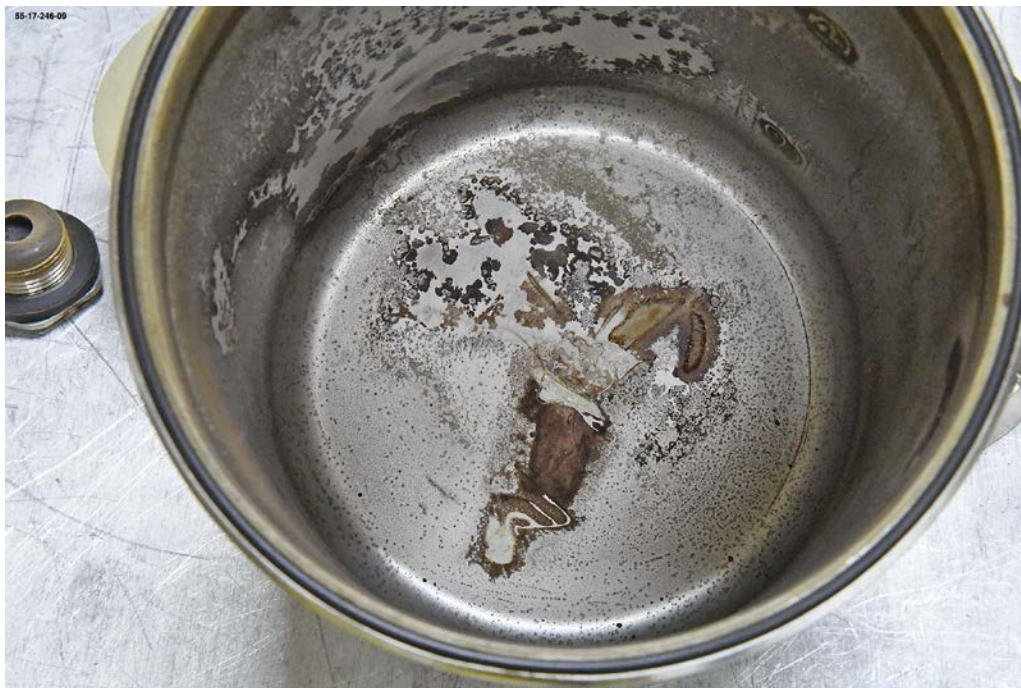
Figure 4-12. Corrosion and markings from the bag-out bag on the bottom of container 17H7.

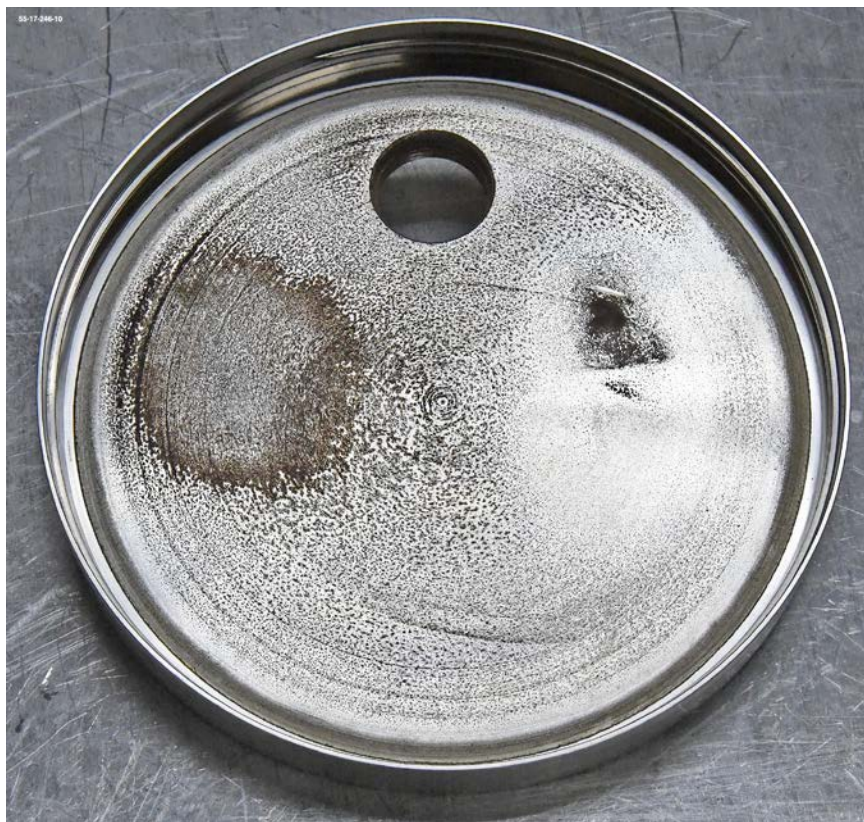
Figure 4-13. Corrosion on underside of the lid of container 17H7.

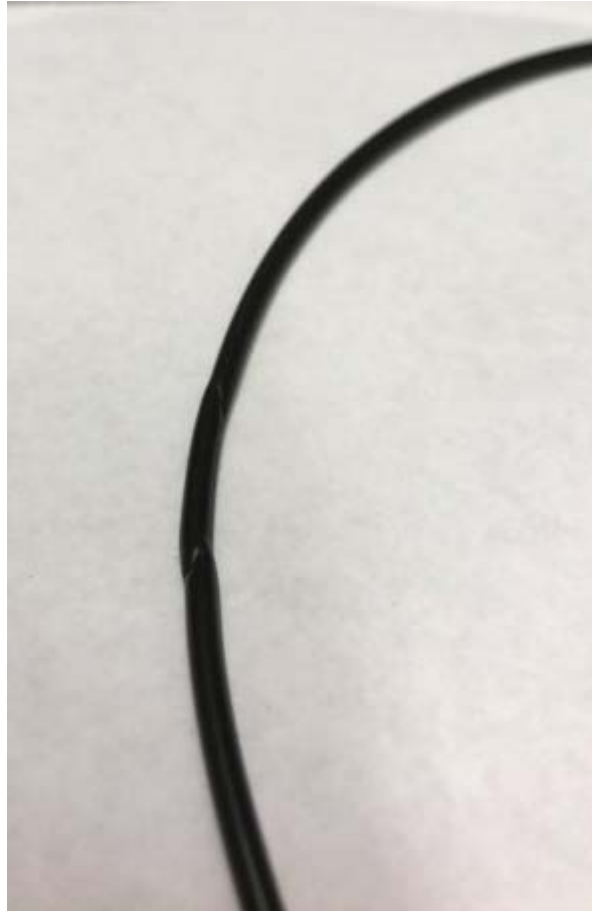
Inspections found one O-ring that failed a visual inspection. This O-ring was on sample #2H. This O-ring was pinched in between lid of the container and the O-ring groove on the body. The O-ring also failed a helium leak test.

Figure 4-14. Pinch visible in O-ring after ~4 weeks removed from container.

The creases in the O-ring seen in Figure 4-14 and Figure 4-15 were found prior to leak testing. The O-ring was kept to observe if the crease from being pinched relaxes, with no significant visible relaxation observed over several months. No other O-rings had any major issue reported.

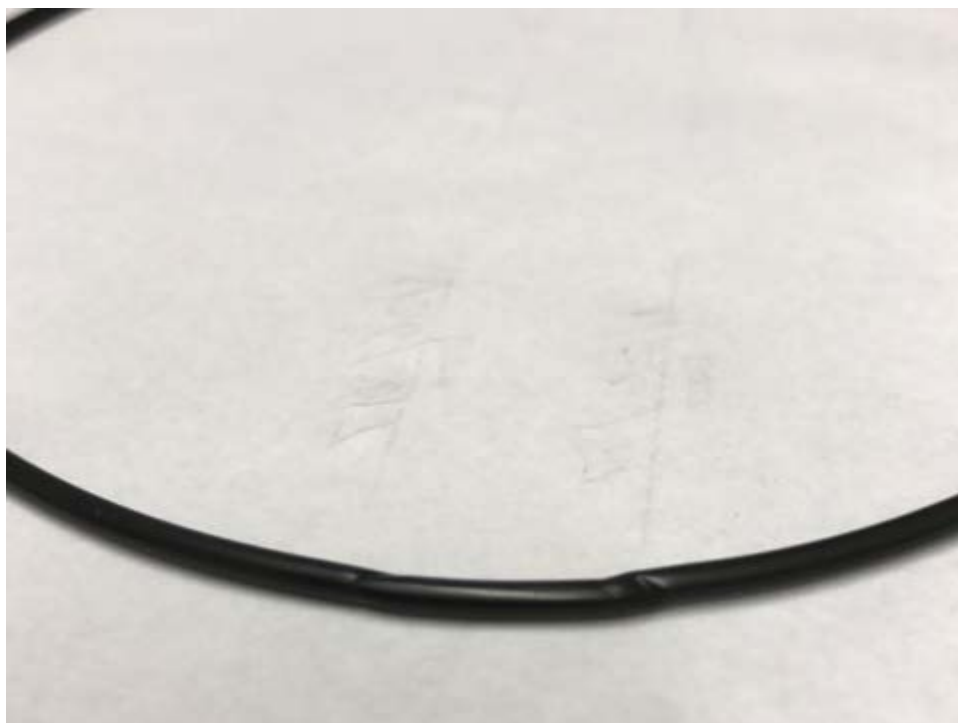
Figure 4-15. Two pinch locations visible on O-ring.

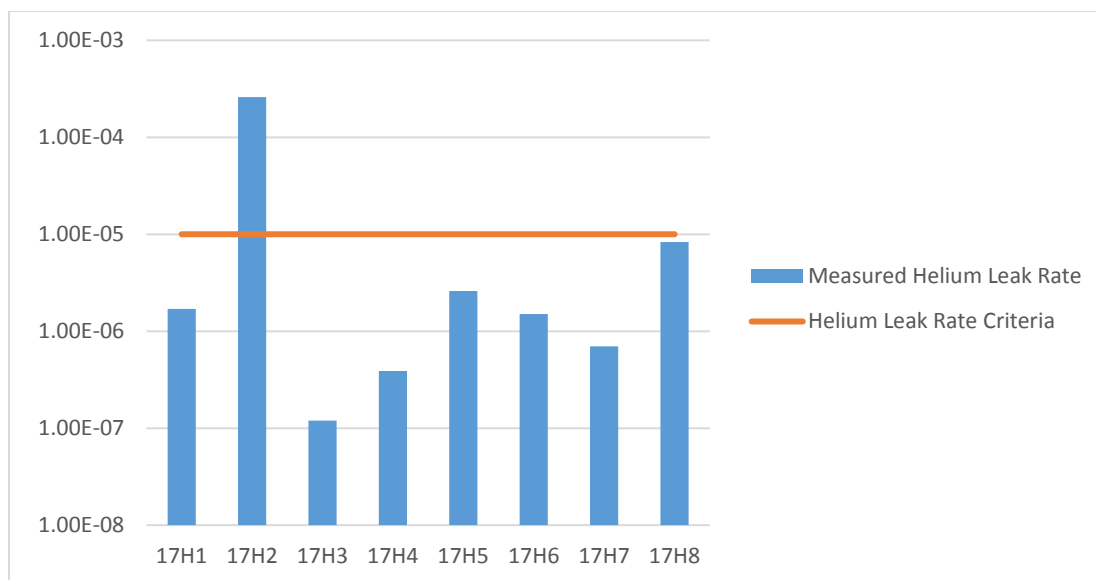
The leak rate results for the Hagan storage containers are shown in Figure 4-16. The measured leak rate from Hagan containers ranged between 1.20×10^{-7} and 2.6×10^{-4} atm cc/s of helium at 75 torr into vacuum. One O-ring failed the leak test, with a measurement above the failure criterion of 1×10^{-5} atm cc/s due to the pinched O-ring.

Figure 4-16. Leak rates measured for each container are shown as blue bars. The orange line shows the failure criteria. One container failed. Values on y-axis are in atmcc/sec.

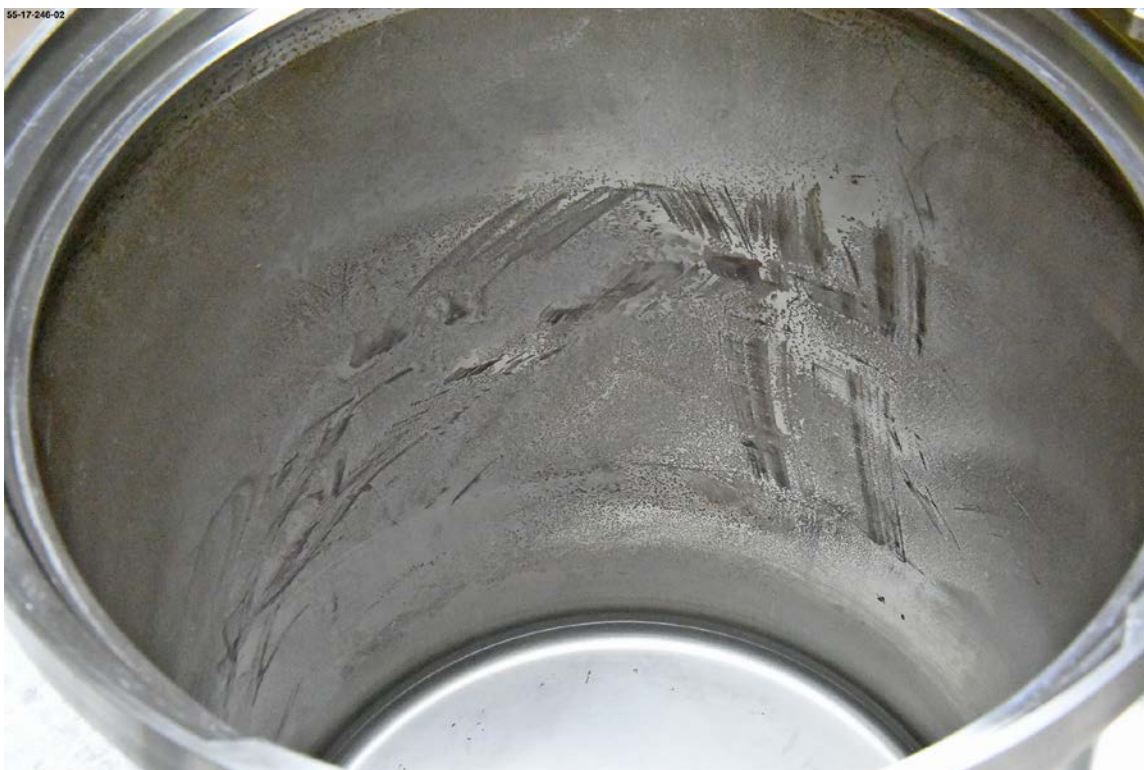
There were no external issues found during the inspection. Corrosion was found inside the container. There were markings where it appears the bag out bag was touching the walls of the container shown in Figure 4-20. Figure 4-21 shows a potentially increased corrosion in the weld region. The bag-out bag was placed into a second bag. The bag was reported in good condition.

Figure 4-20. Bag out bag marking on the wall of the container 17S1.

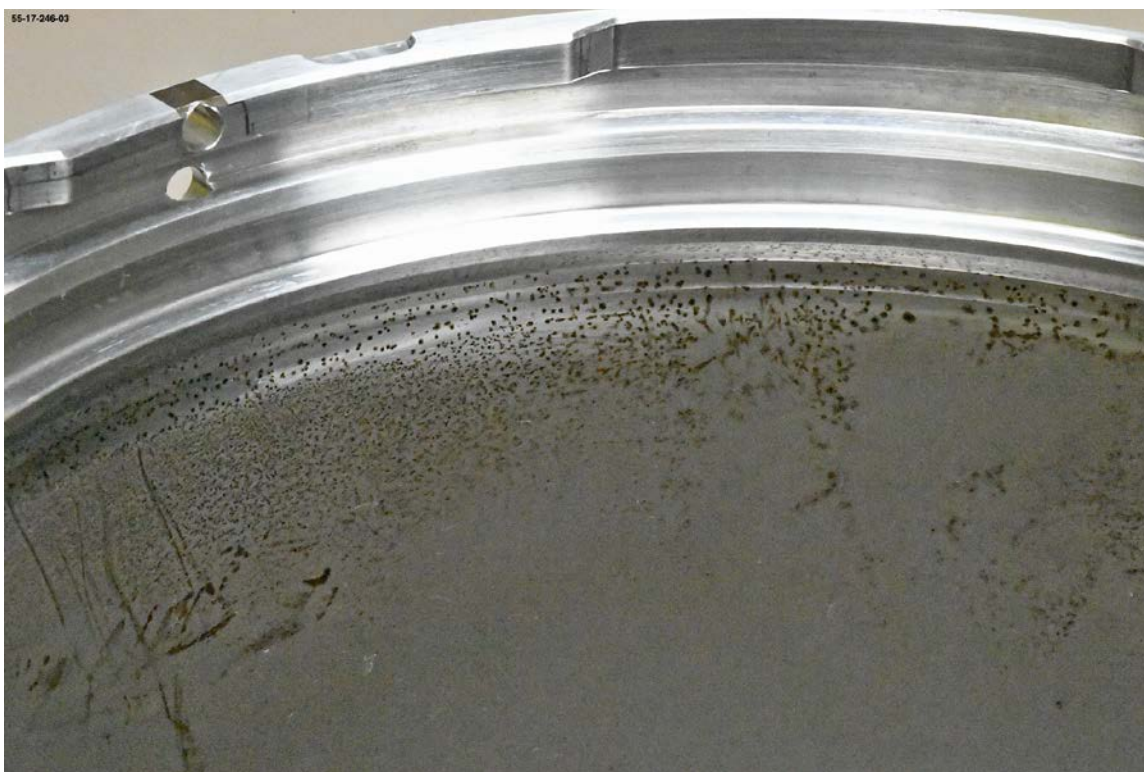
Figure 4-21. Corrosion seen in the weld region of the container 17S1.

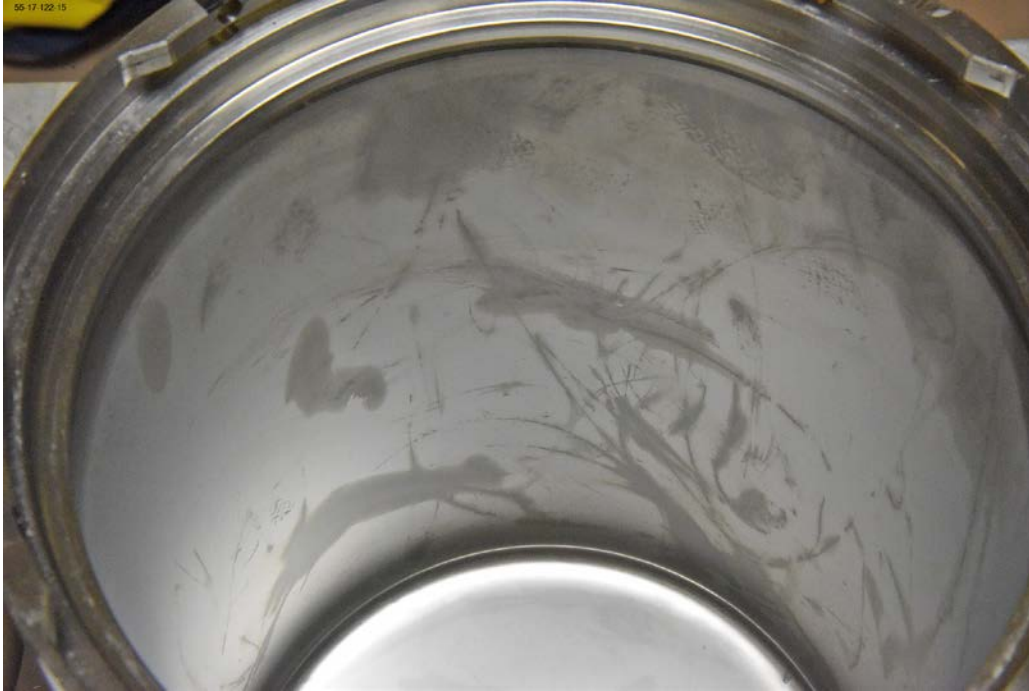
Figure 4-23. Section of container 17S3 wall prior to wiping with isopropyl alcohol wipe.

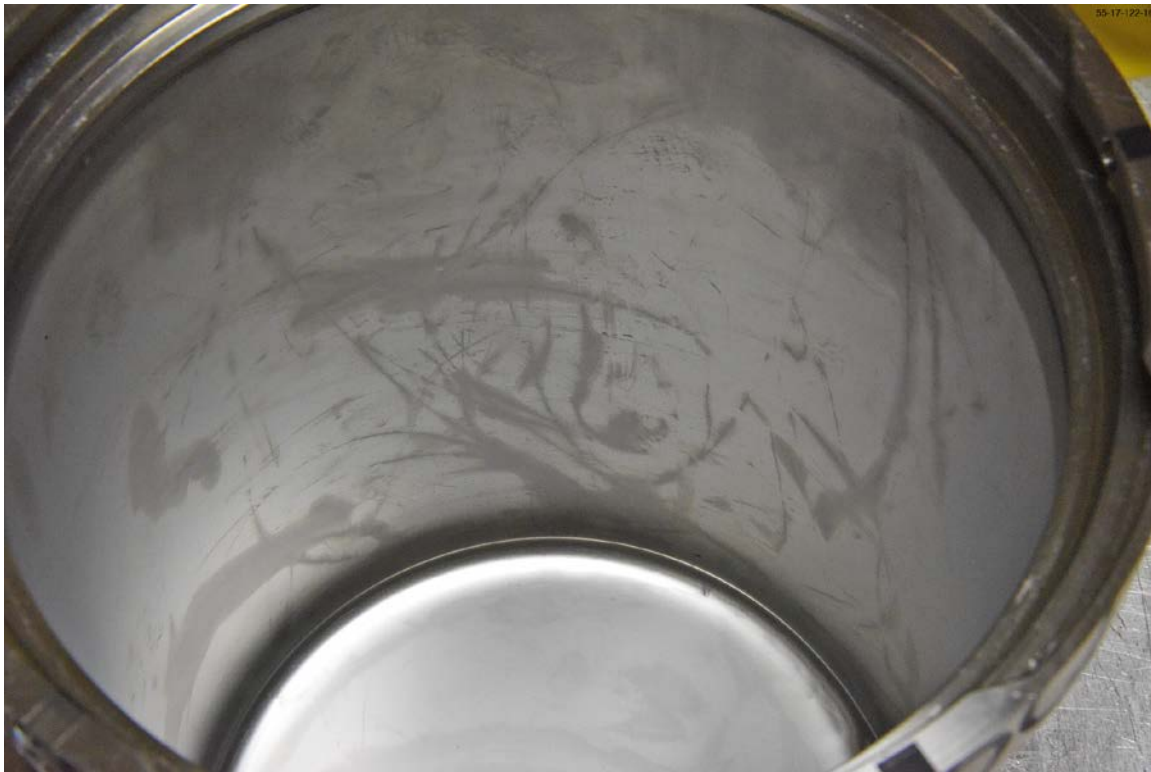
Figure 4-24. Section of container 17S3 wall after wiping.

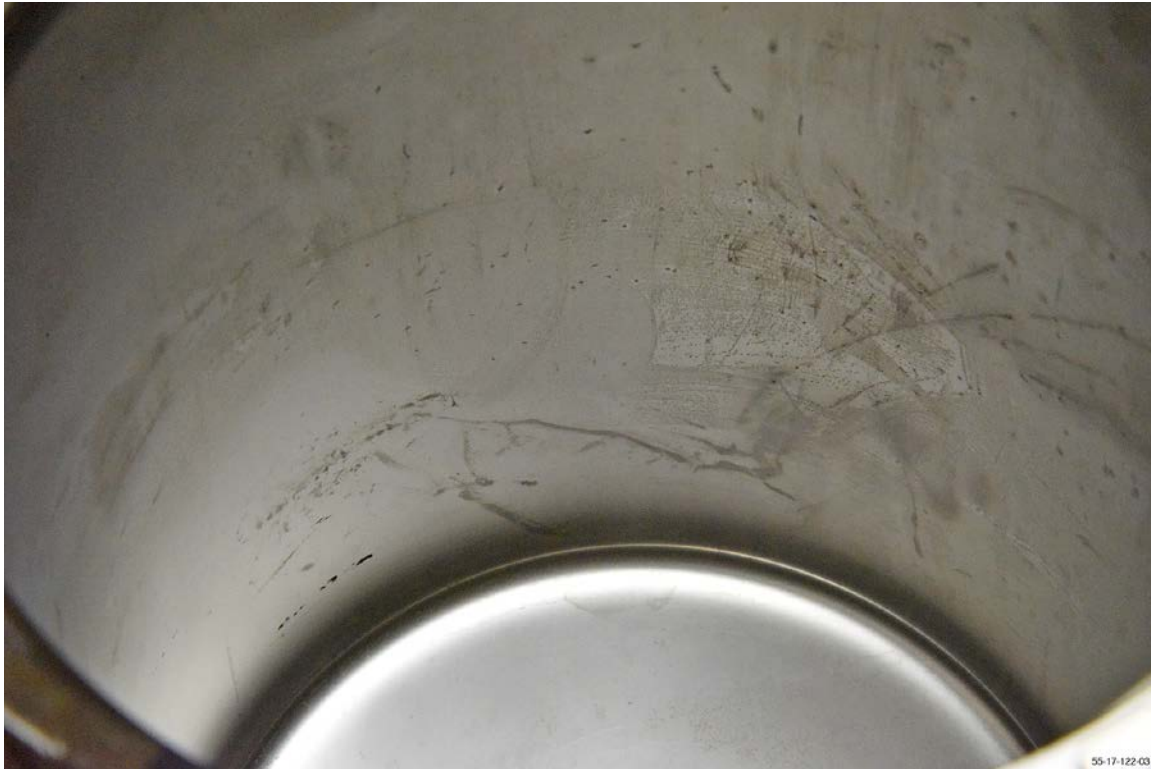
Minor corrosion found on the interior walls of the container seen in Figure 4-25. The suspected corrosion was wiped with an isopropyl alcohol wipe and the residue was brown in color with the pre- and post- wipe container wall being seen in Figure 4-26 and Figure 4-27. The bag out bag was reported to be in good condition.

Figure 4-25. Marks of the bag out bag on the container 17S4 wall. Appears concentration at a crease of the bag out bag touches the wall.

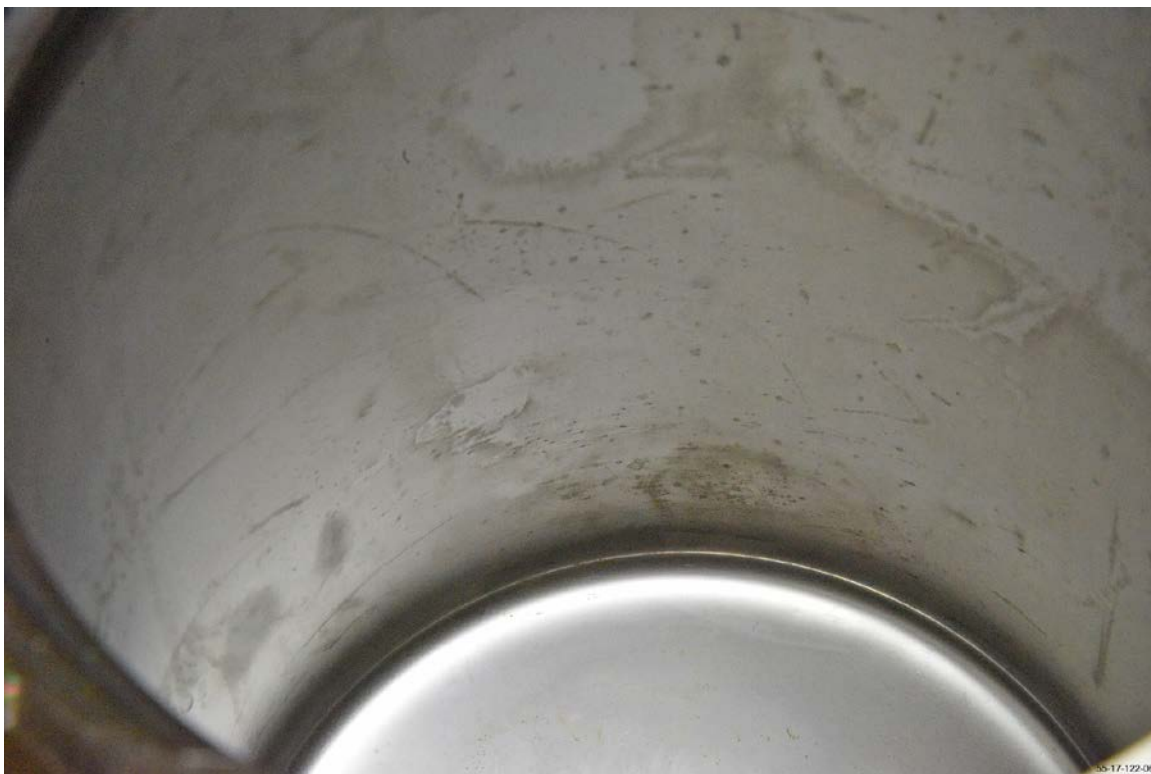
Figure 4-26. Container 17S4 wall prior to wiping.

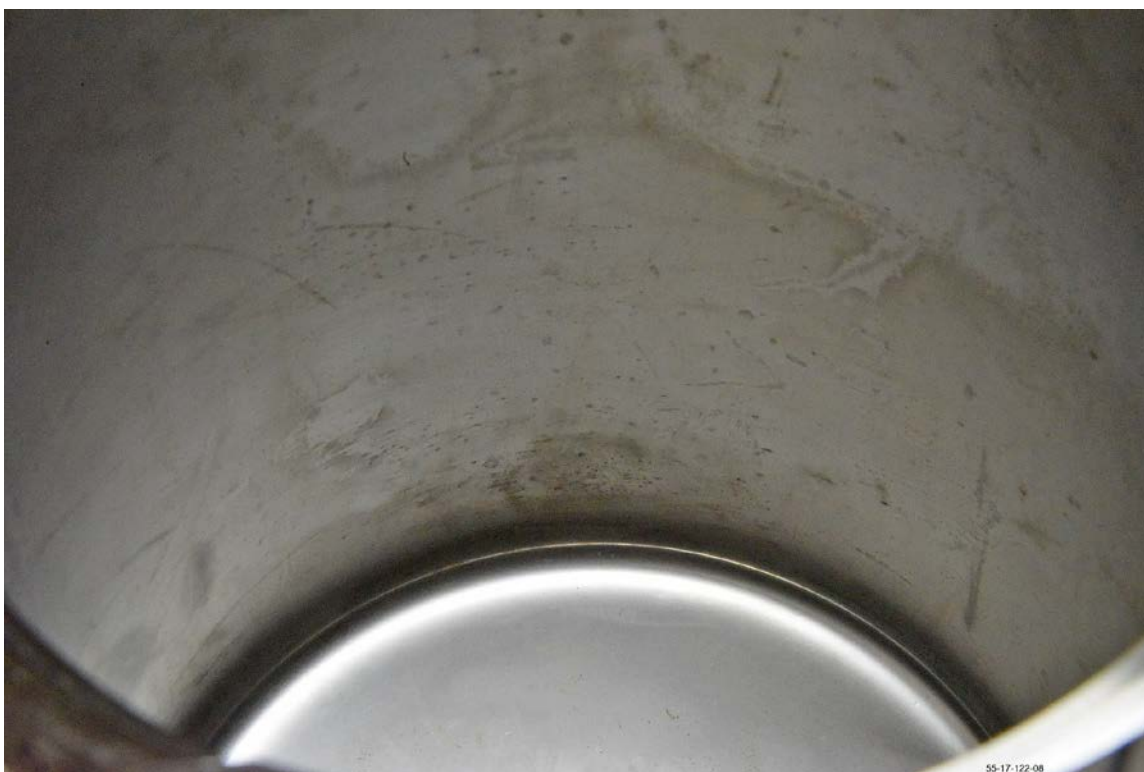
Figure 4-27. Container 17S4 wall after wiping.

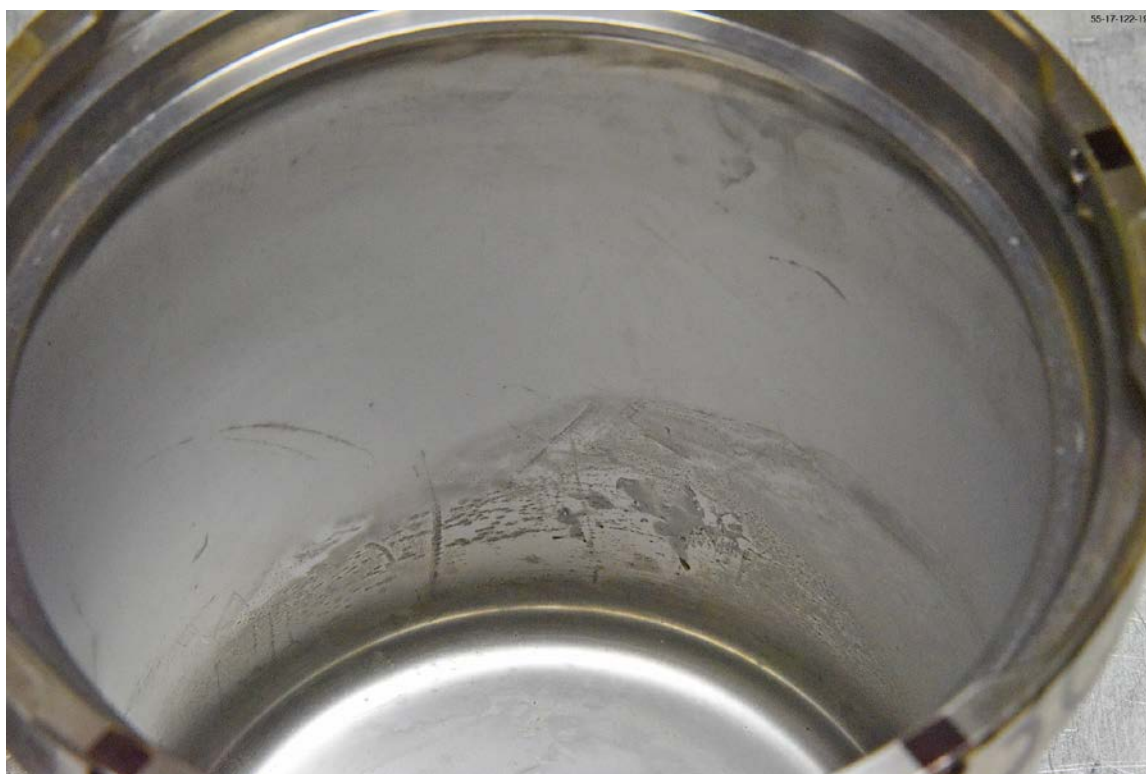
Minor corrosion found on the inner walls of the container. The corrosion appears heavier on the lower portion of the walls and the bottom of the container seen in Figure 4-28 which is unlike the corrosion concentration area seen in other containers. The container was wiped with the results being seen in Figure 4-29. The bag-out bag was reported in good condition. No other visual issues were identified.

Figure 4-28. Container 17S5 wall prior to wiping. Suspect corrosion closer to bottom of container.

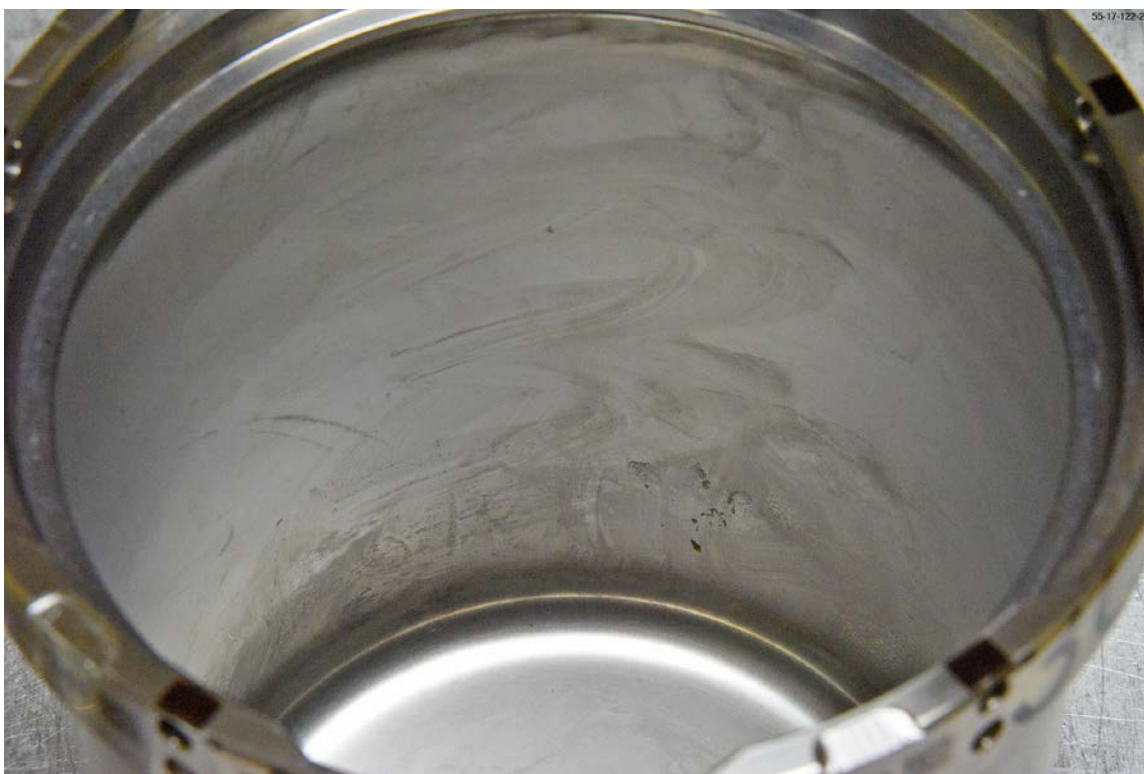
Figure 4-29. Container 17S5 wall after being wiped.
